Tuckerman Service Tips

Thermocouple Lead, Piezo Lead and Thermocouple Spring Replacement

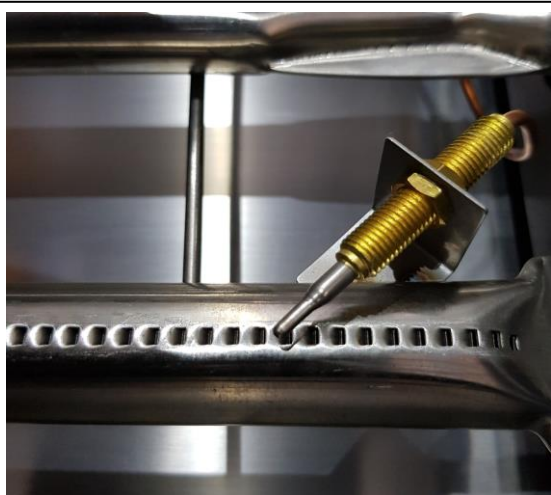
Figure (a) Thermocouple Placement

Before dismantling take note of the positioning of both the Thermocouple Copper lead (figures a & b) and Black Piezo lead (figure c), so that the replacements are put into the correct position when finished.

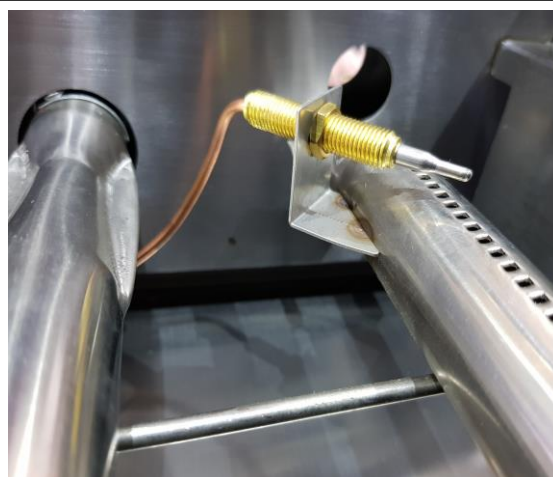
Figure (b) Height of Thermocouple above burner
Should be approximately 2-3mm

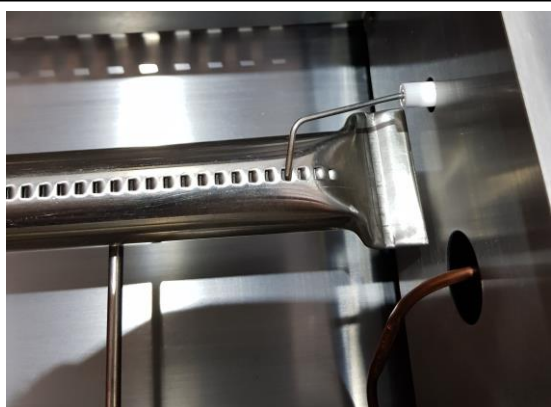
Figure (c) Piezo Ignitor Position 1.5-3mm above
Gas vent outlets

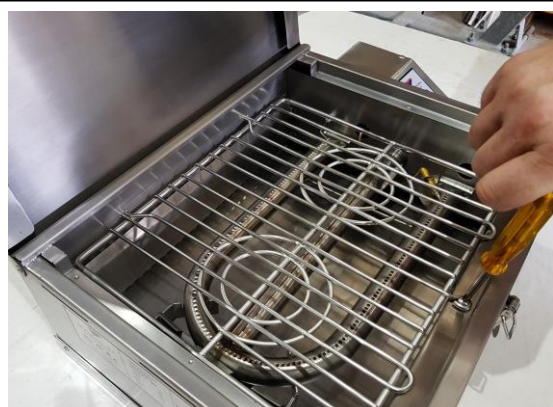
(1) Undo retaining screw to remove oven wire

To remove the burner, remove the semi-permanent Oven Wire by unscrewing the retaining screw and sliding it out of the rear keeper holes.

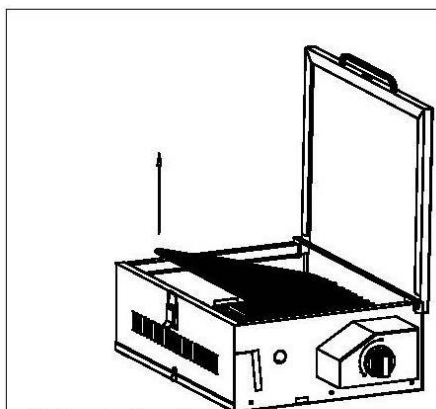
(1) Remove Oven Wire

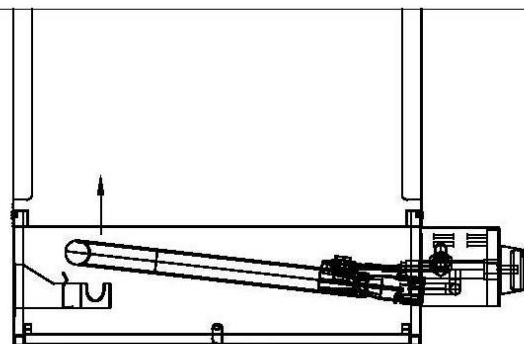
(2) Lift Left Side Of Burner

- (1) Unbolt the thermocouple (copper tube with probe end, adjacent the Piezo lead) securing nut on the face side of the thermocouple holder bracket to allow the burner to slide out (the second rear nut, at the back of the thermocouple holder bracket, should be left as is).
- (2) Lift the left end of the burner up and out of the securing clip.
- (3) Slide to the left, off the gas control valve and out of the thermocouple locator, and lift out, (see below).

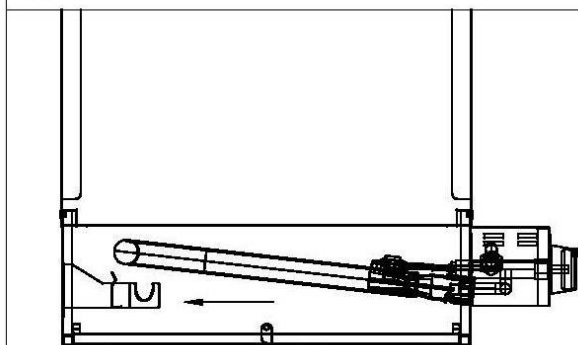
(3) Slide Burner To Left

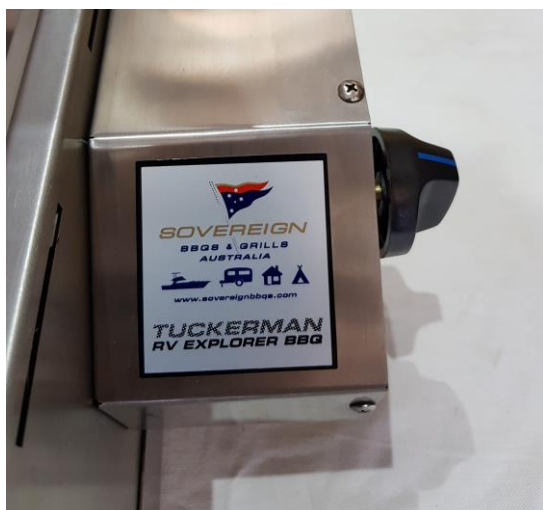
(4) Pull Control Knob Straight off

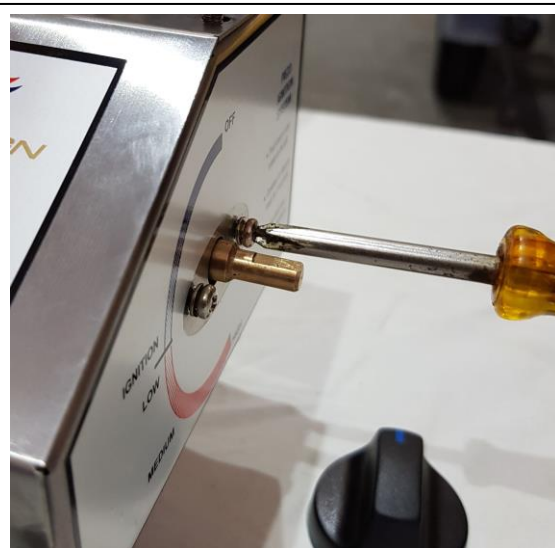
(5) Remove Screws from under Control Knob

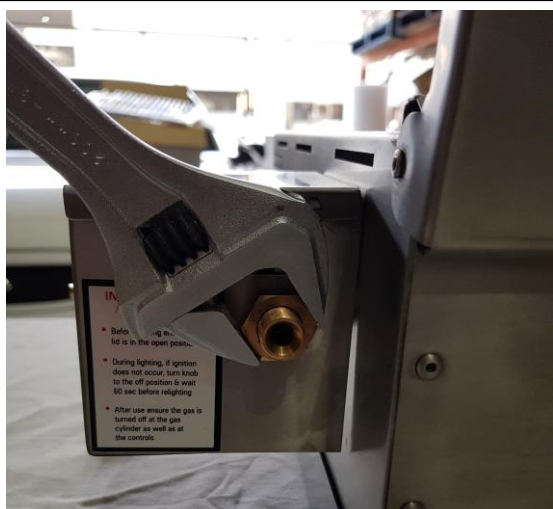
(6) Undo bolt at rear of control box

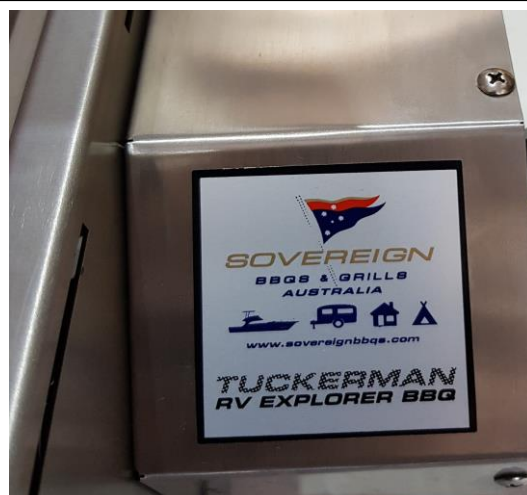
(7) Undo 4 screws and remove control box

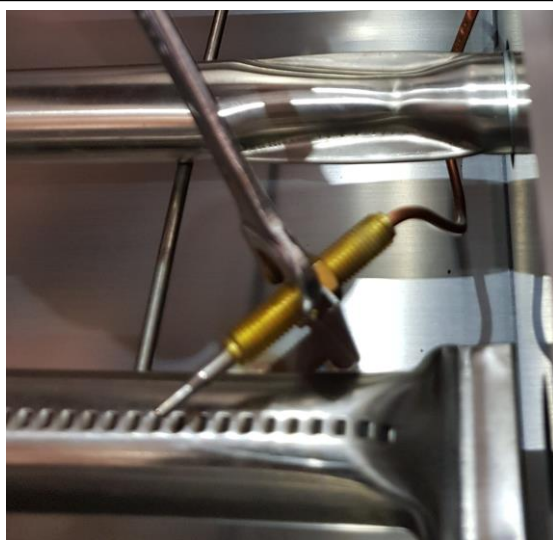
(8) Undo thermocouple nut (closest to tip)

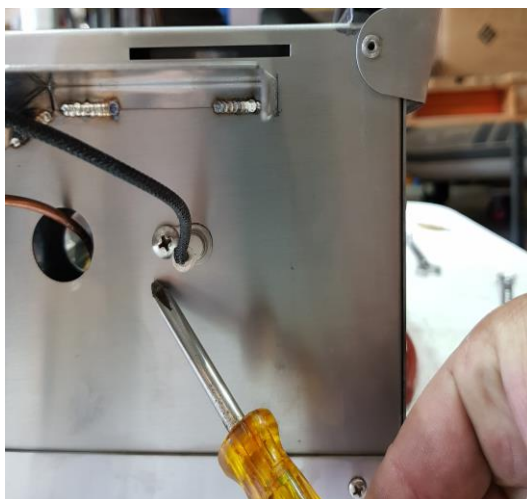
(9) Undo screw underneath housing to remove Piezo

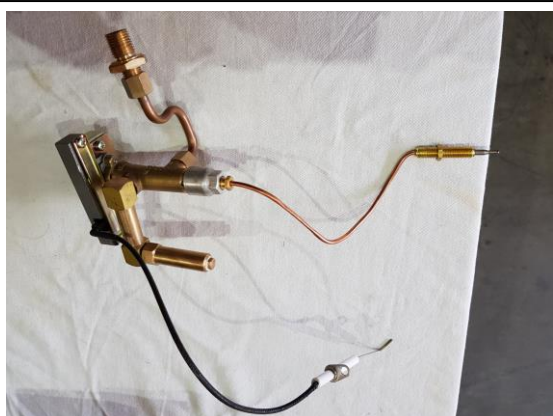
(10) Remove whole valve complete with Thermocouple and Piezo

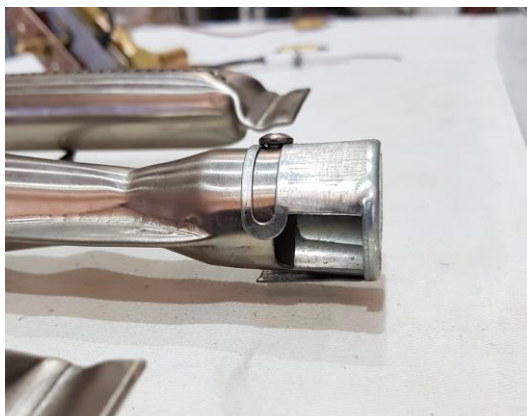
(11) Check Air Vent on Burner is in correct position

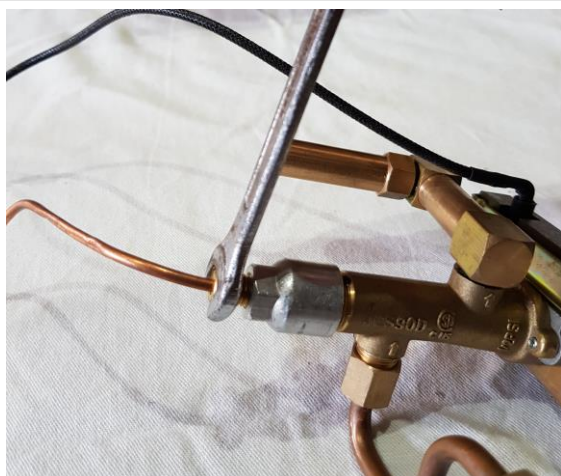
(12) Undo nut to remove Thermocouple from Valve

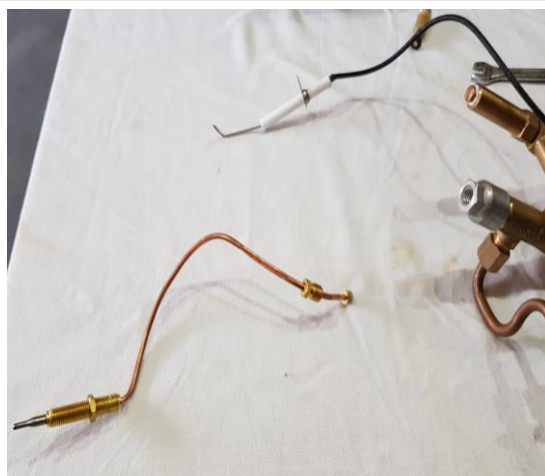
(13) Picture shows Thermocouple removed from Valve

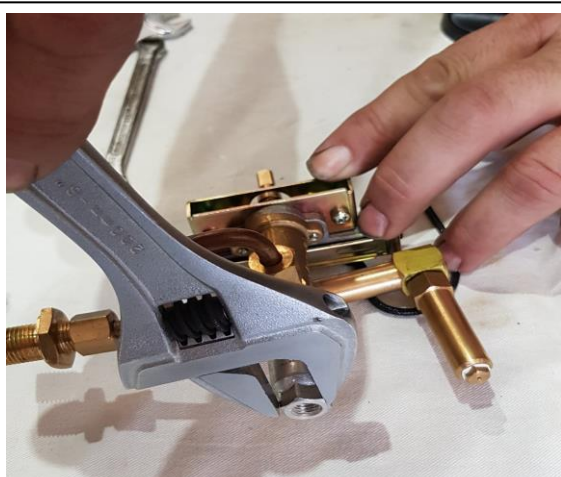
(14) Now undo Bolt that thermocouple came out of to remove the Inner Spring Mechanism

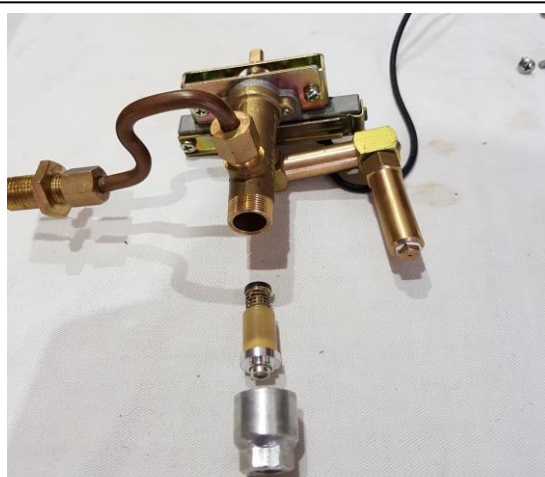
(15) Picture shows Inner Spring after removal of bolt

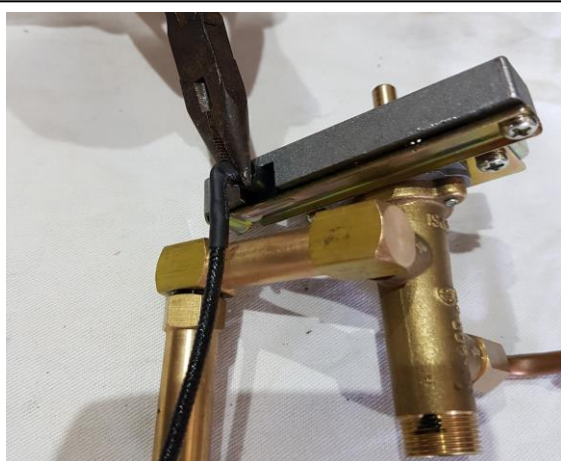
(16) Note Piezo position before you take it off as the replacement needs to be put in the same position

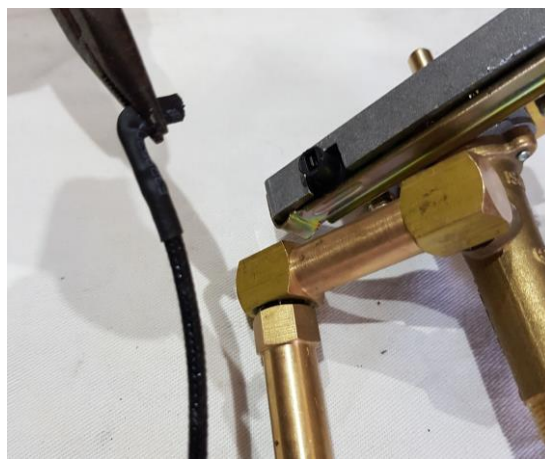
(17) Pull the Piezo off the main part of the valve

To reassemble or to add new parts, assemble and re-install in the reverse order from (17) back to (1).

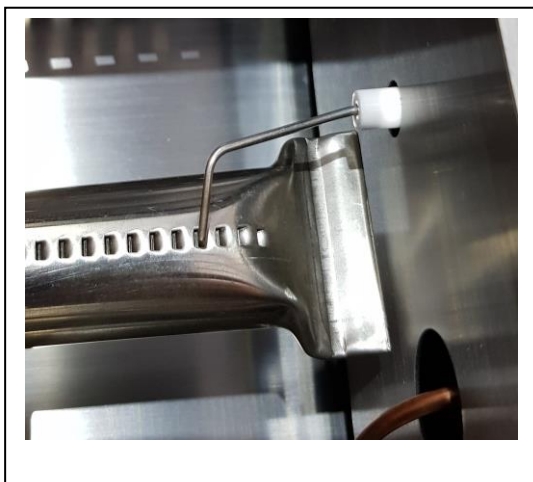
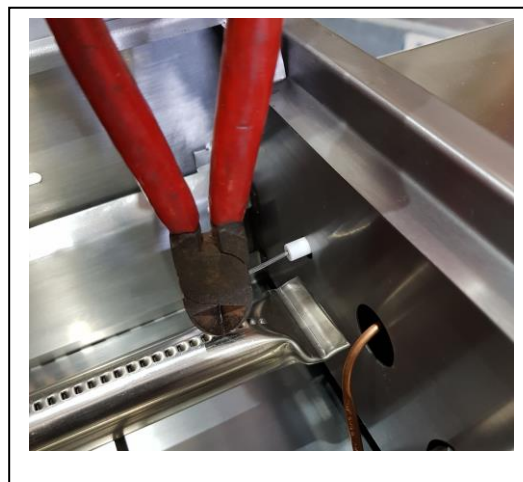
- When there is no spark from the Piezo Ignitor, try cleaning the tip with a very fine sand paper. If it still does not spark try cutting the very tip off the Piezo with a sharp pair of pliers. If neither of these actions work then the Piezo will need replacing.
- If your BBQ turns itself off as soon as you let go the Control Knob then that would indicate that the Control Knob is faulty or damaged in some way. To test this, pull the Control Knob straight off and try starting your BBQ with a pair of pliers. If the flame does not go out then your Control Knob needs replacing.
- Replacement parts can be ordered on our website www.sovereignbbqs.com .
